plugin 1030

CONTINENTAL MCM2.1 IROM TC1797 MEB TRUCK

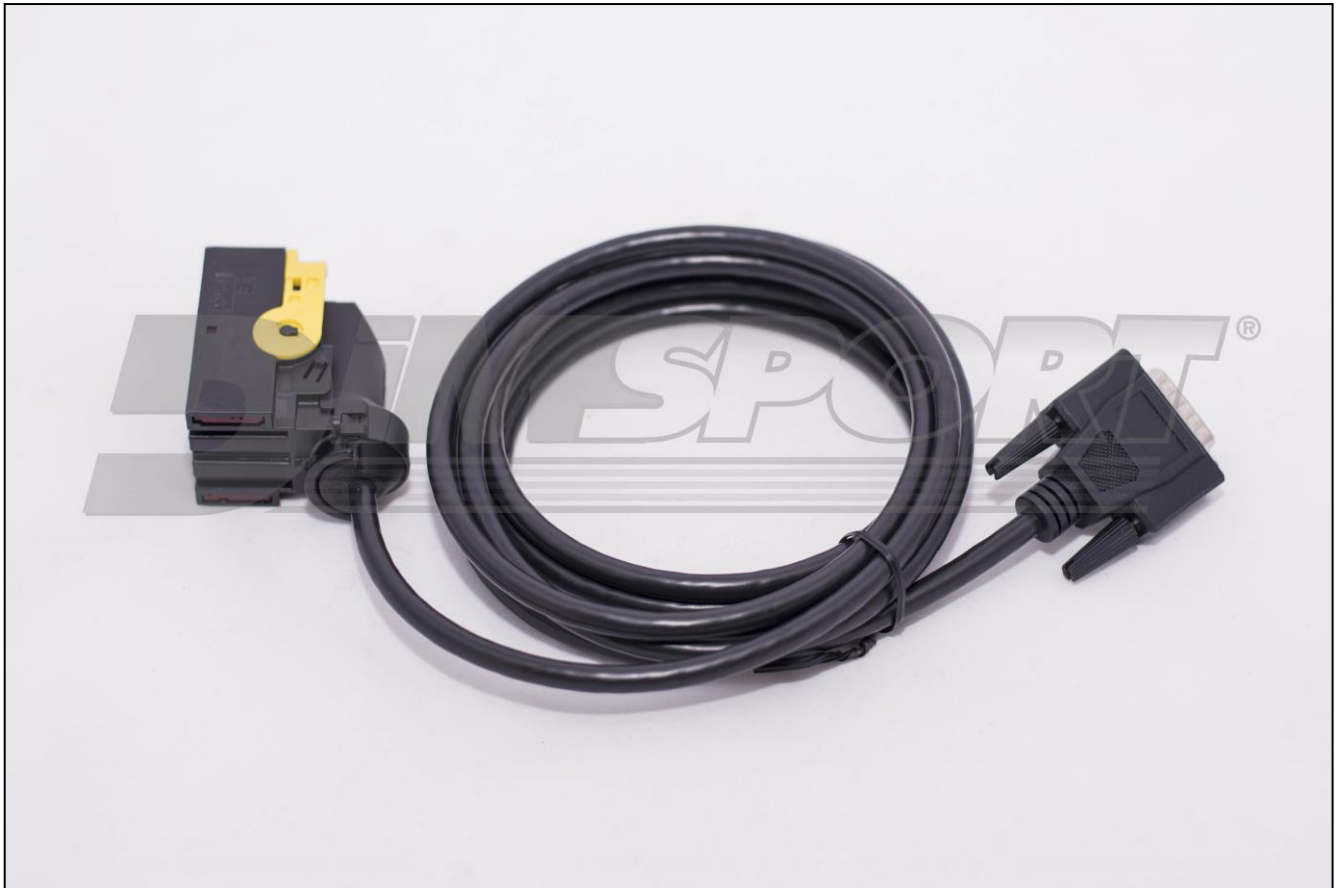
F34NTA19

The required cable for the correct communication is F34NTA19.

WARNING: for a correct communication both vehicle connectors must be disconnected from the ECU. Connect first the cable to the Trasdata, then to the ECU, ONLY after you can connect the power to the Trasdata.

At the end of the communication procedures detach first power from the Trasdata and then the ECU connector.
