CONTINENTAL SID208 IROM TC1797 FORD LANDROVER

plugin **510 - 803 - 965**

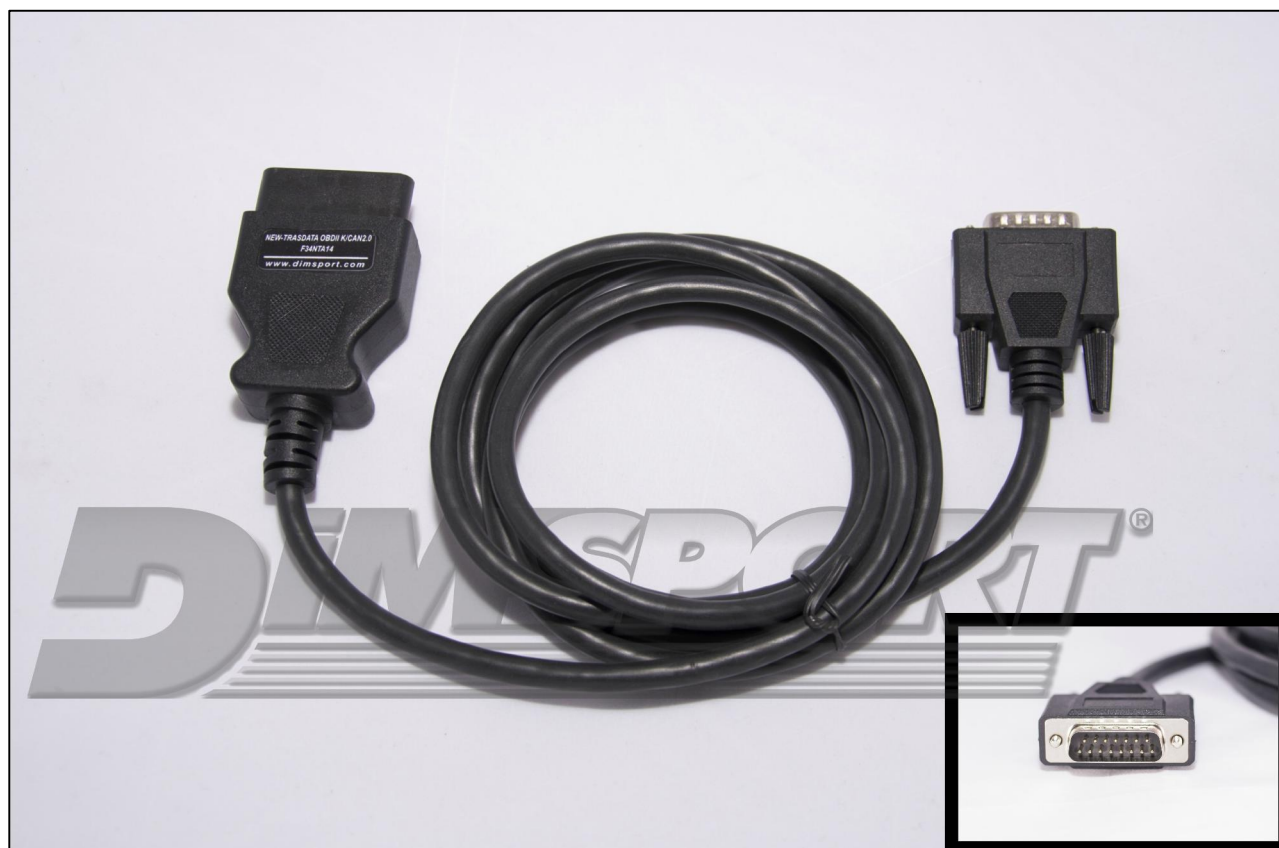
Required cable for ObdData operation: F34NTA14

1. connect Trasdata tool to the pc via USB
2. connect F34NTA14 cable to the Trasdata DB25 port
3. connect the F34NTA14 cable to the vehicle OBDII port
4. run the sw to manage the Trasdata tool
5. select the correct connection mode for the vehicle
6. click on ObdData button
7. wait until the end of the ObdData procedure

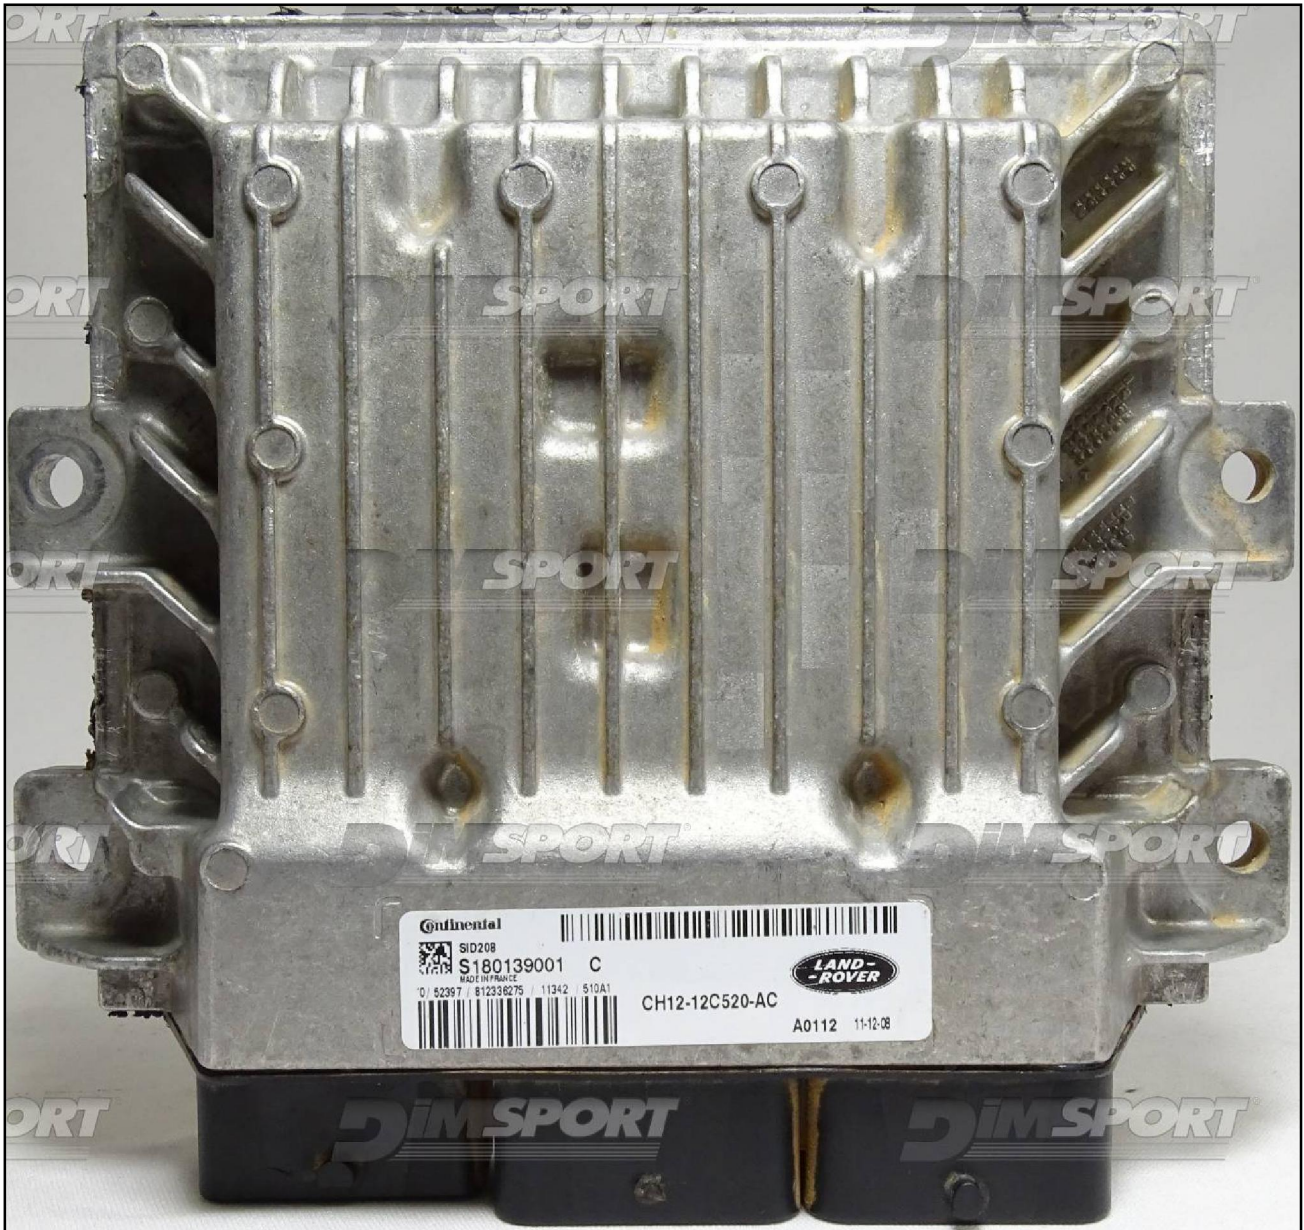
On this ECU you can use two different connection approaches:

1. Metal positioning frame connection with F34DM032 adapter
2. Direct connection

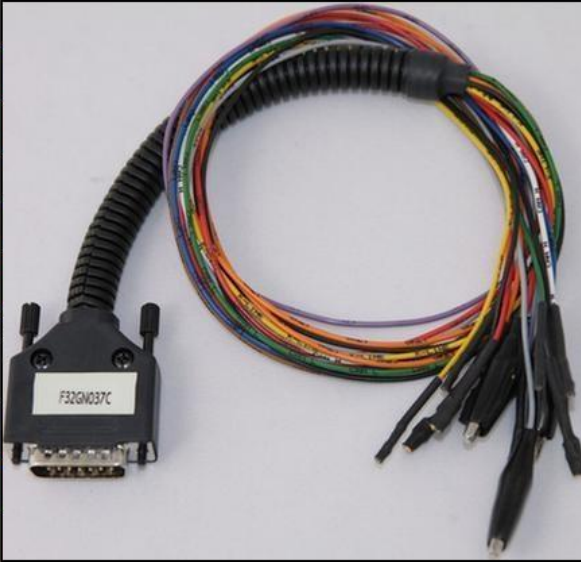
ECU CONNECTOR

In order to connect to the ECU use the CABLE F32GN037C.
 Make sure that the POWER led (red) on Trasdata is ON.

These connections are required for all the connection approaches: metal positioning frame adapter and direct connection.

COLORE FILO WIRE COLOUR	DESCRIZIONE DESCRIPTION
ROSSO RED	POSITIVO DIRETTO POWER BATTERY
ARANCIO ORANGE	POSITIVO SOTTO QUADRO POWER SWITCH ON
NERO BLACK	MASSA GND
GIALLO YELLOW	KLINE
VERDE GREEN	CAN LOW
BIANCO WHITE	CAN HIGH
GRIGIO GREY	POL4 BOOT
BLU BLUE	POL5 CNF1
VIOLA/GRIGIO PURPLE/GREY	TENSIONE PROG. PROG. VOLTAGE
MARRONE BROWN	RESET

To pin 28-39, instead of connecting the VKEY signals (orange wires), connect 2 power signals +12V (red wires), in this way you should have only three red wires + 12V to pin 5-28-39

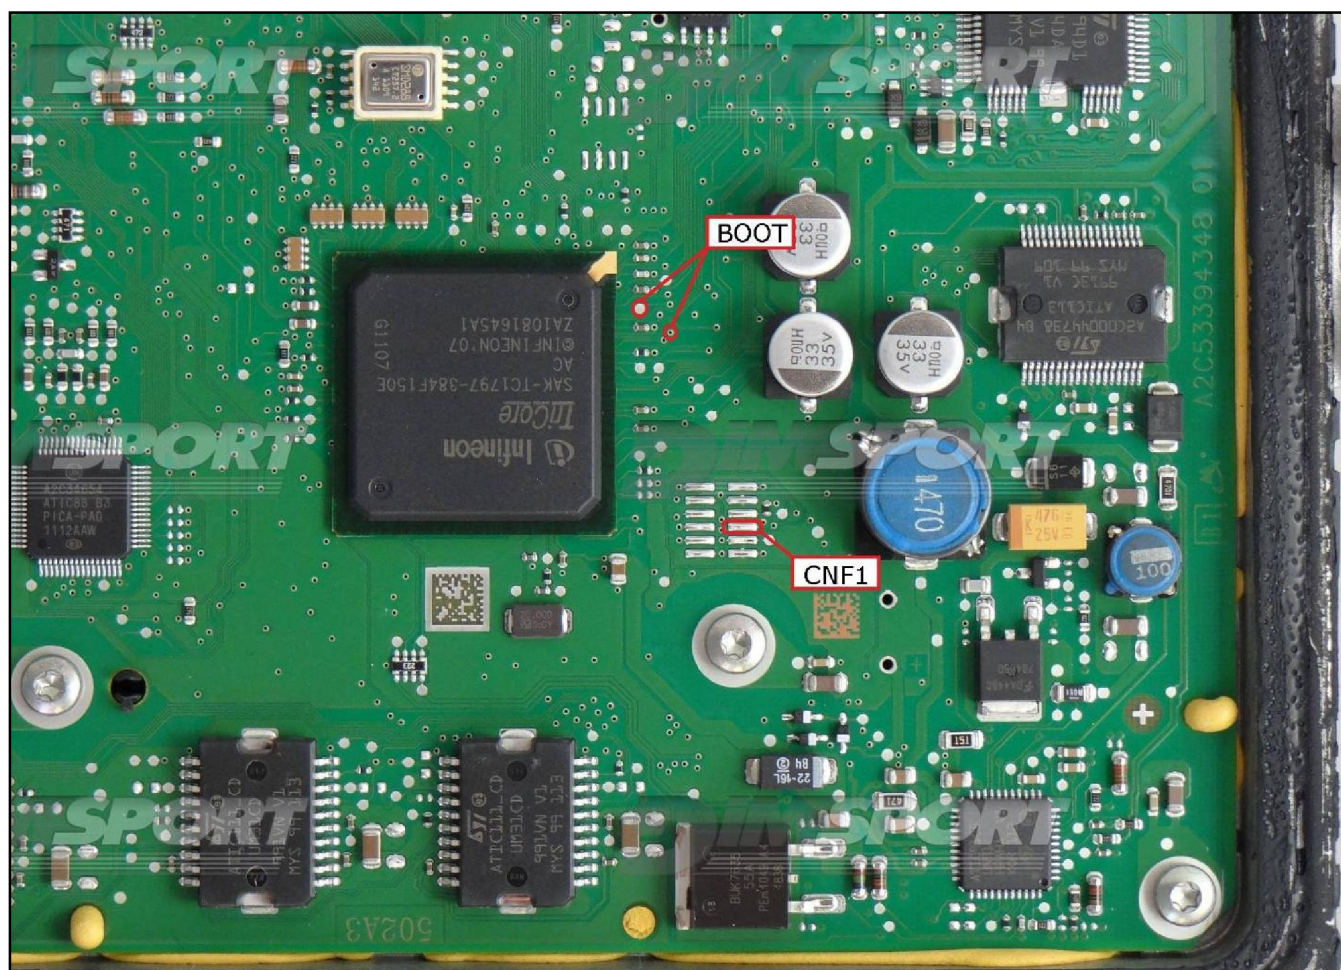
2. DIRECT BOOT&CNF1 CONNECTION

Connect the BLUE and GREY wires of the cable F32GN037C as described here below :

COLORE FILO WIRE COLOUR	DESCRIZIONE DESCRIPTION
GRIGIO GREY	POL4 BOOT
BLU BLUE	POL5 CNF1
